**THE STREAMBANK EROSION CONTROL  
EVALUATION AND DEMONSTRATION ACT OF 1974  
SECTION 32, PUBLIC LAW 93-251**

## Appendix F - Yazoo River Basin Demonstration Projects

# FINAL REPORT TO CONGRESS

U.S. ARMY CORPS OF ENGINEERS  
December 1981

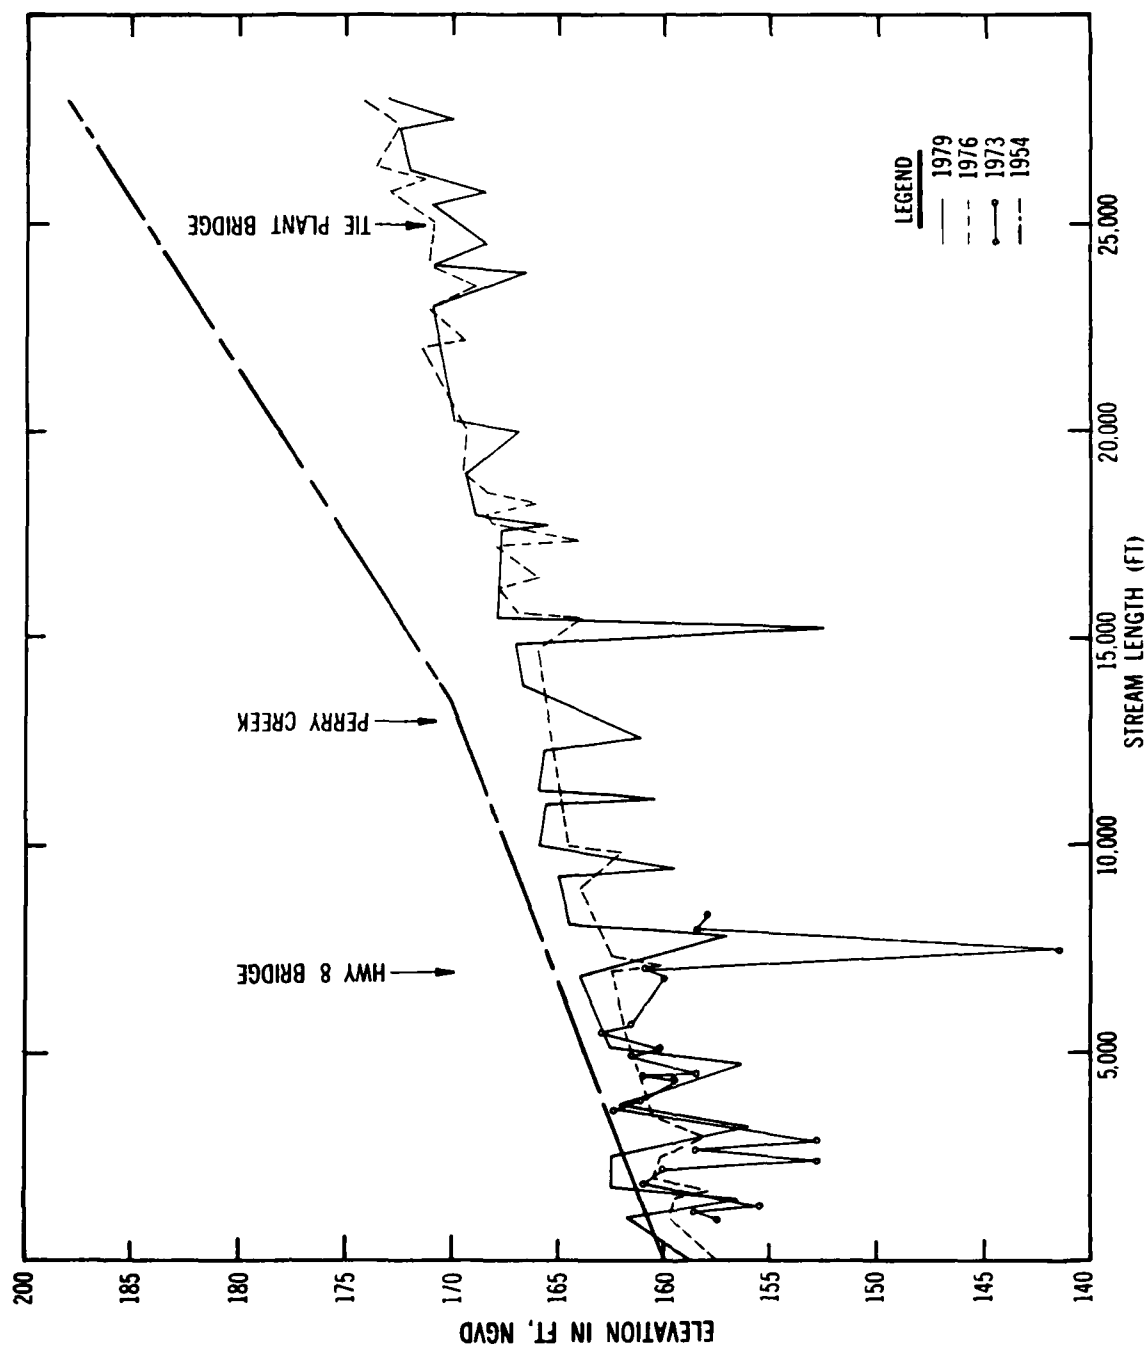
Figure 30. Thalweg profile Ratupan Bogue

Figure 30 shows a bed-level lowering from 1954 to the late 1970's of 2 to 5 feet for the stream channel up to the Perry Creek confluence (2 miles) and over 7 feet continuing upstream. The later profiles of this figure show aggradation of 2 to 3 feet from the Yalobusha River confluence upstream approximately 3 miles. Little change is noted for the next 1-1/2 miles with 2 feet of degradation continuing upstream.

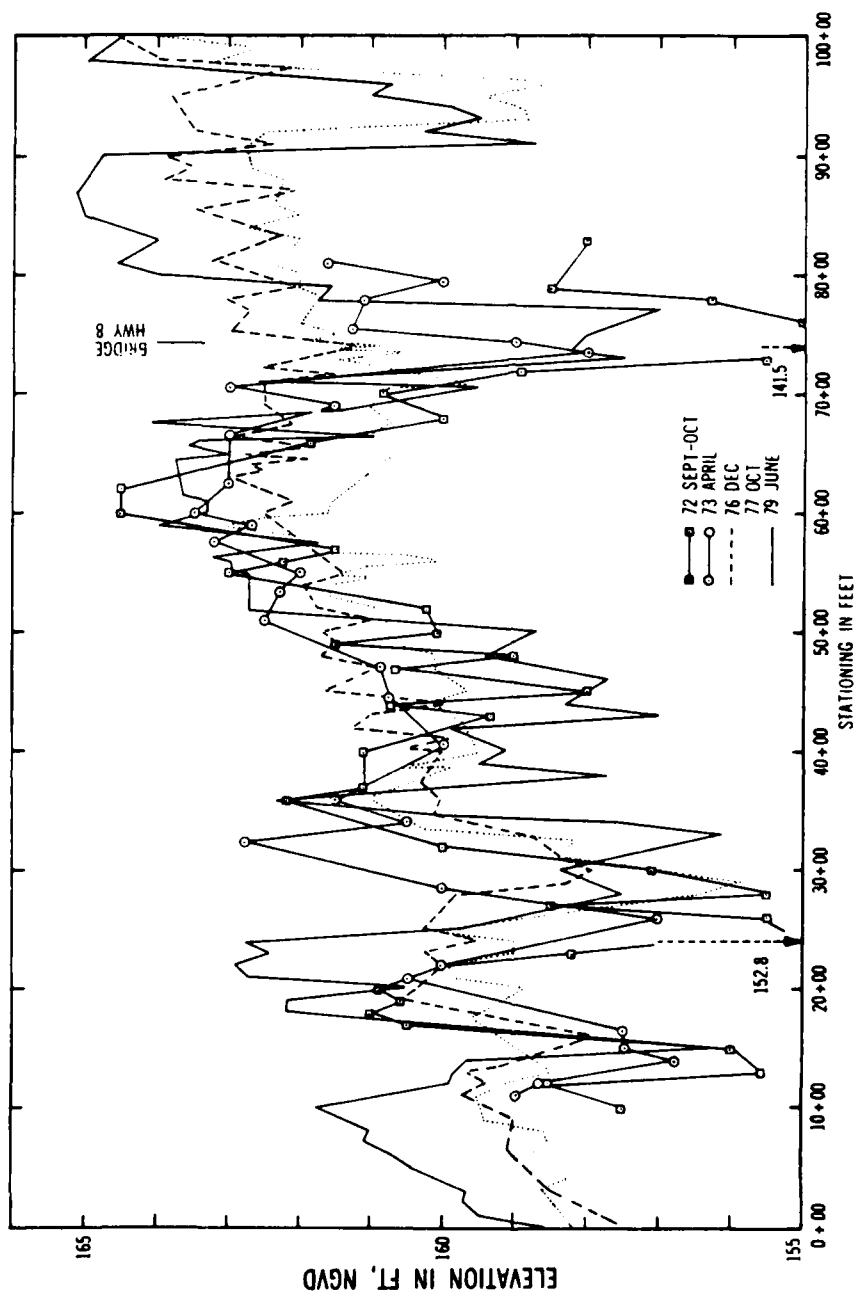
Figure 31. Thalweg profile Batupan Bogue

Figure 31 shows the large scour and fill processes for the thalweg which have occurred since 1972 over the lower 2 miles of stream channel. Summarizing these data, the thalweg has generally aggraded 2 to 3 feet over this stream reach.

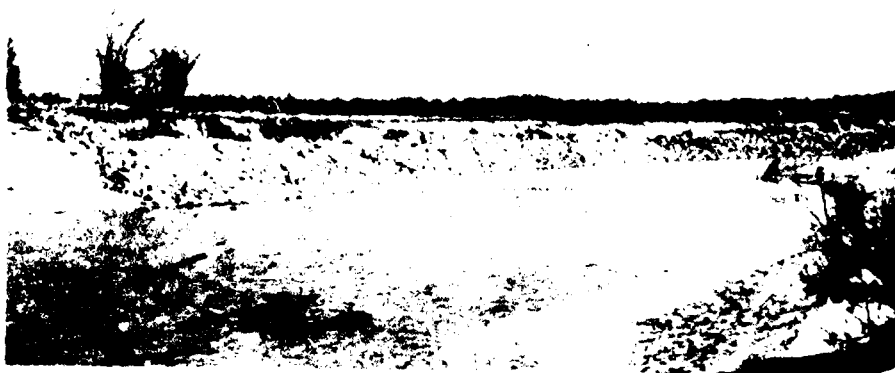
Figure 46. Batupan Bogue, Item 4, Reach 5

After Construction  
Jan 1979

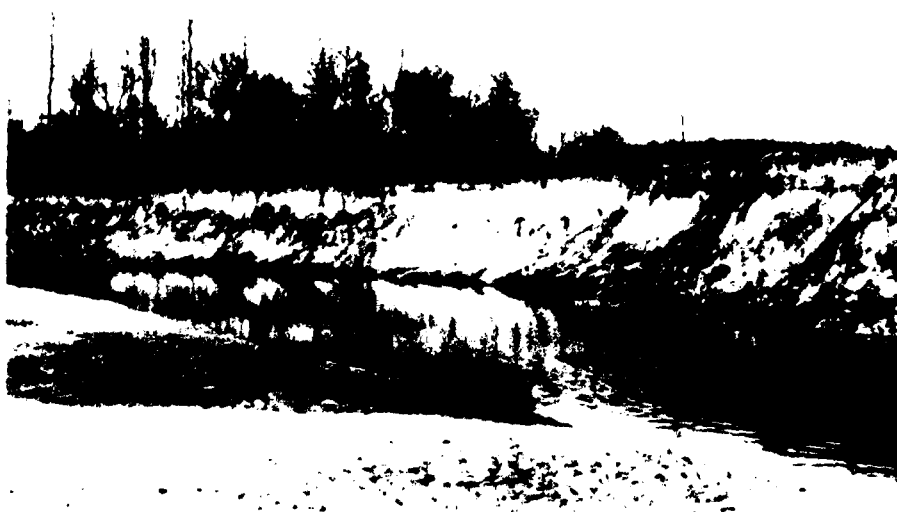
Area to be Rehabbed FY-81  
Mar 1981

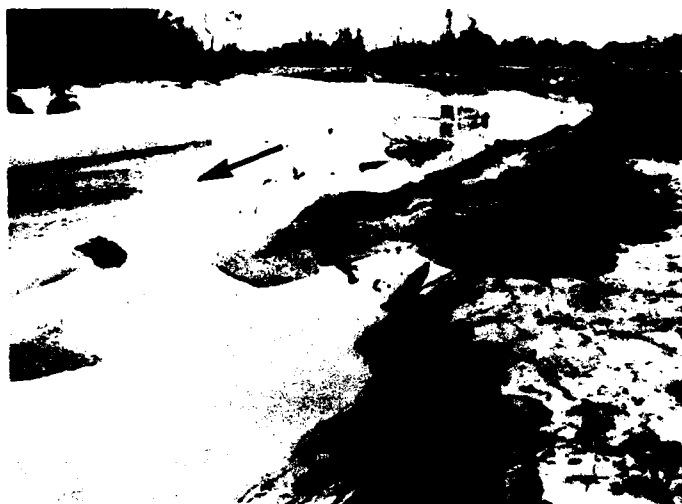
Figure 48. Batupan Bogue, Item 4, Reach 8

After Rehab Work  
1979

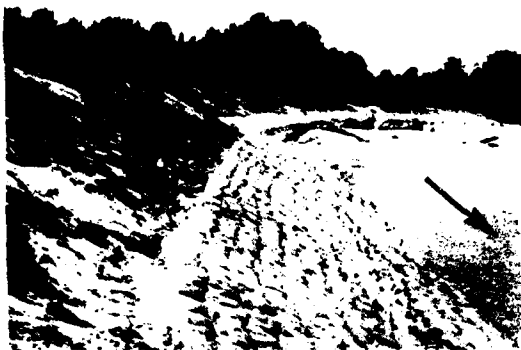
Figure 49. Batupan Bogue, Item 4, Reach 9

After Construction  
Item 4A  
Nov 1977

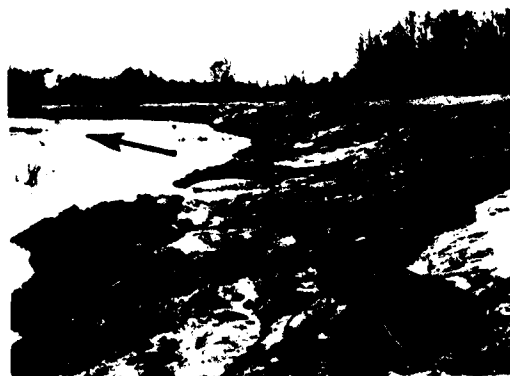
Damage Before 1981  
Rehab

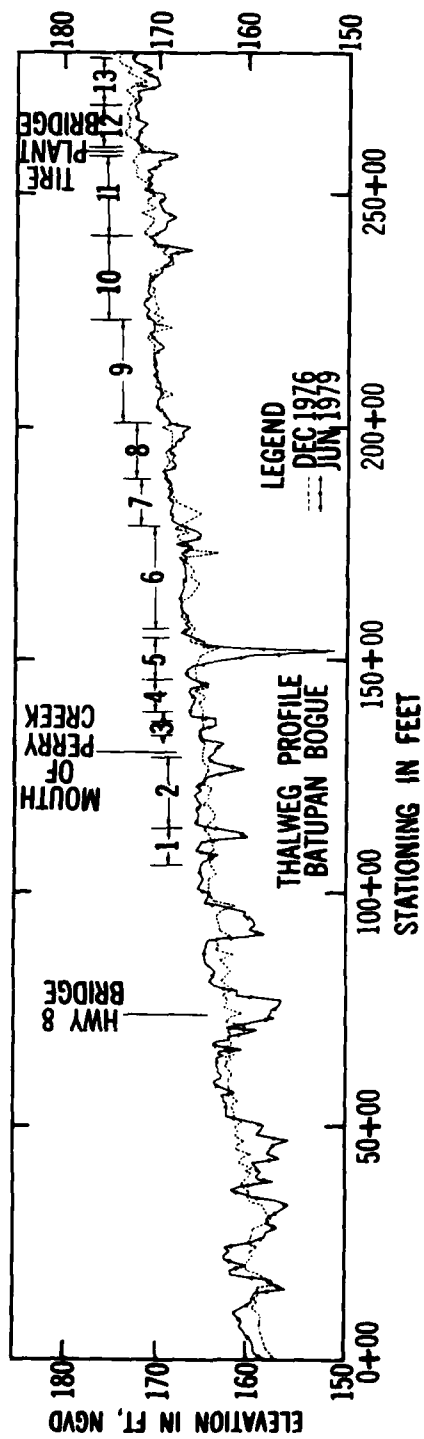
Figure 54. Batupan Bogue Thalweg, 1976 and 1979

With the exception of a few reaches, the Item 4A work has generally had little launching of the stone toe protection due to scour, even where massive bank failures have occurred. According to comparative thalweg profiles (Figure 54), the streambed between Reach 1 and Reach 9 has remained relatively stable with only localized areas of scour and fill. This indicates the presence of a consolidated streambed which the stream cannot penetrate; therefore, during high flows the banks are scoured rather than the bed. Because of the consolidated bed material, the bank failures are due to the erosive forces of the stream impinging on the upper banks, rather than as a result of an oversteepening of the banks following a lowering of the streambed. In areas where geologic bed controls exist, complete upper bank protection with minimal toe protection may be the most suitable design. This design differs considerably from actively degrading streams such as Perry Creek where toe protection is essential to providing adequate bank protection. It is important to recognize that a complete study of the area is necessary to insure that the optimum stabilization techniques for the stream are selected. Several factors such as alignment, incomplete upper bank protection, and

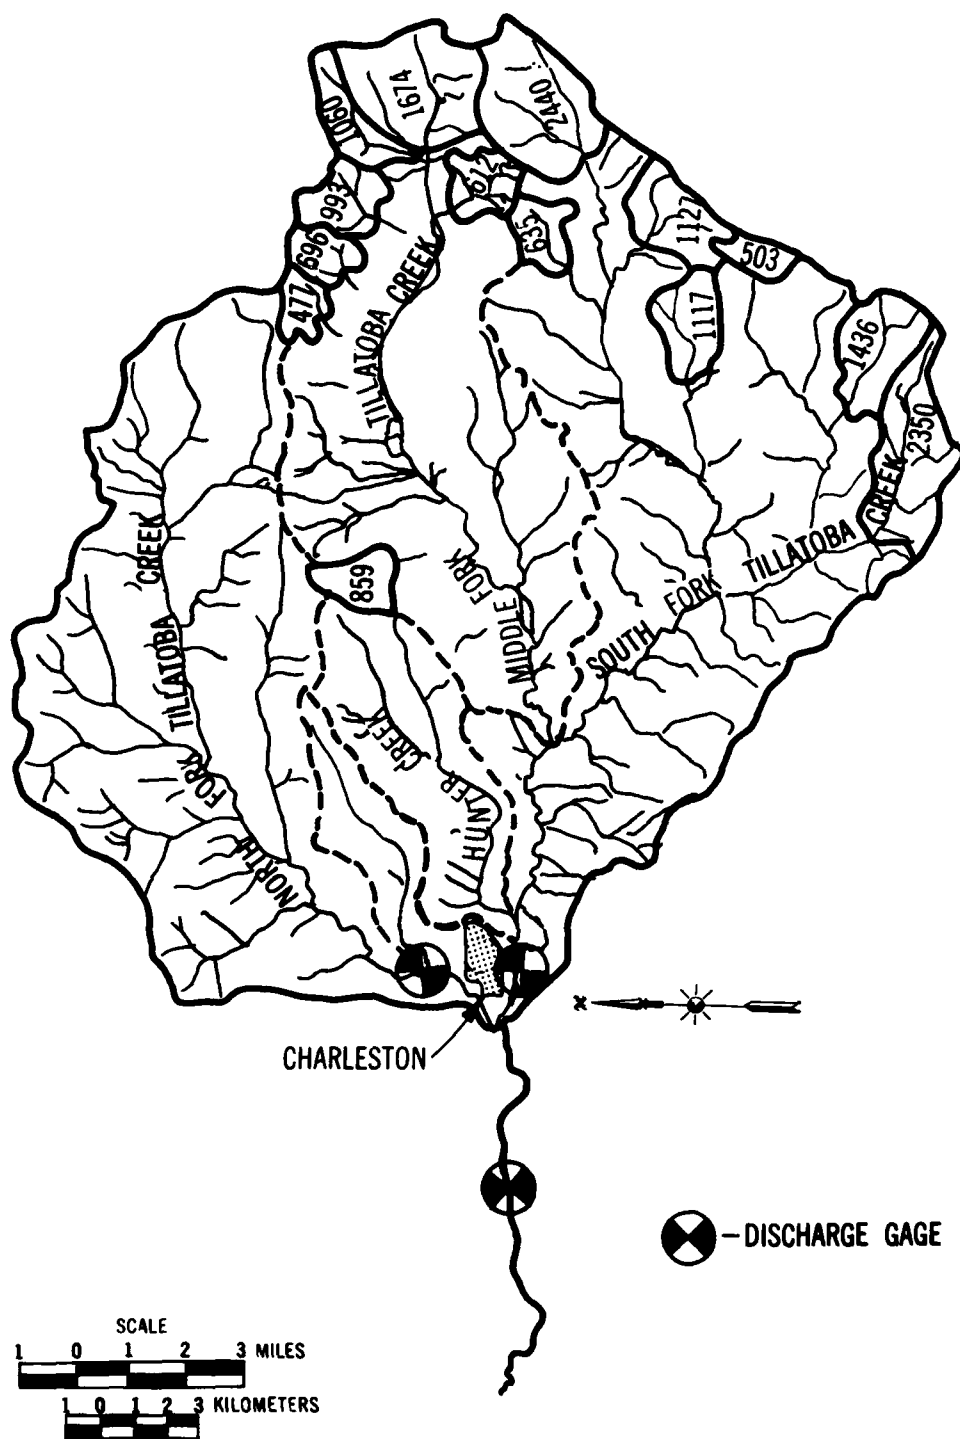
Figure 59. SCS impoundments in Tillatoba Drainage Basin

Other significant projects in the basin are the construction of 15 small, flood-retarding structures in the upper portions of the South Fork Watershed by the USDA-Soil Conservation Service controlling approximately 25 sq mi, or 14 percent, of the total drainage basin runoff and 21 percent of South Fork runoff. These small reservoirs have drainage areas ranging from 447 to 2,440 acres. The construction of these works is now in its final stages of completion and the total effect on flows near Charleston is not known. The sub-basins being controlled are shown in Figure 59.

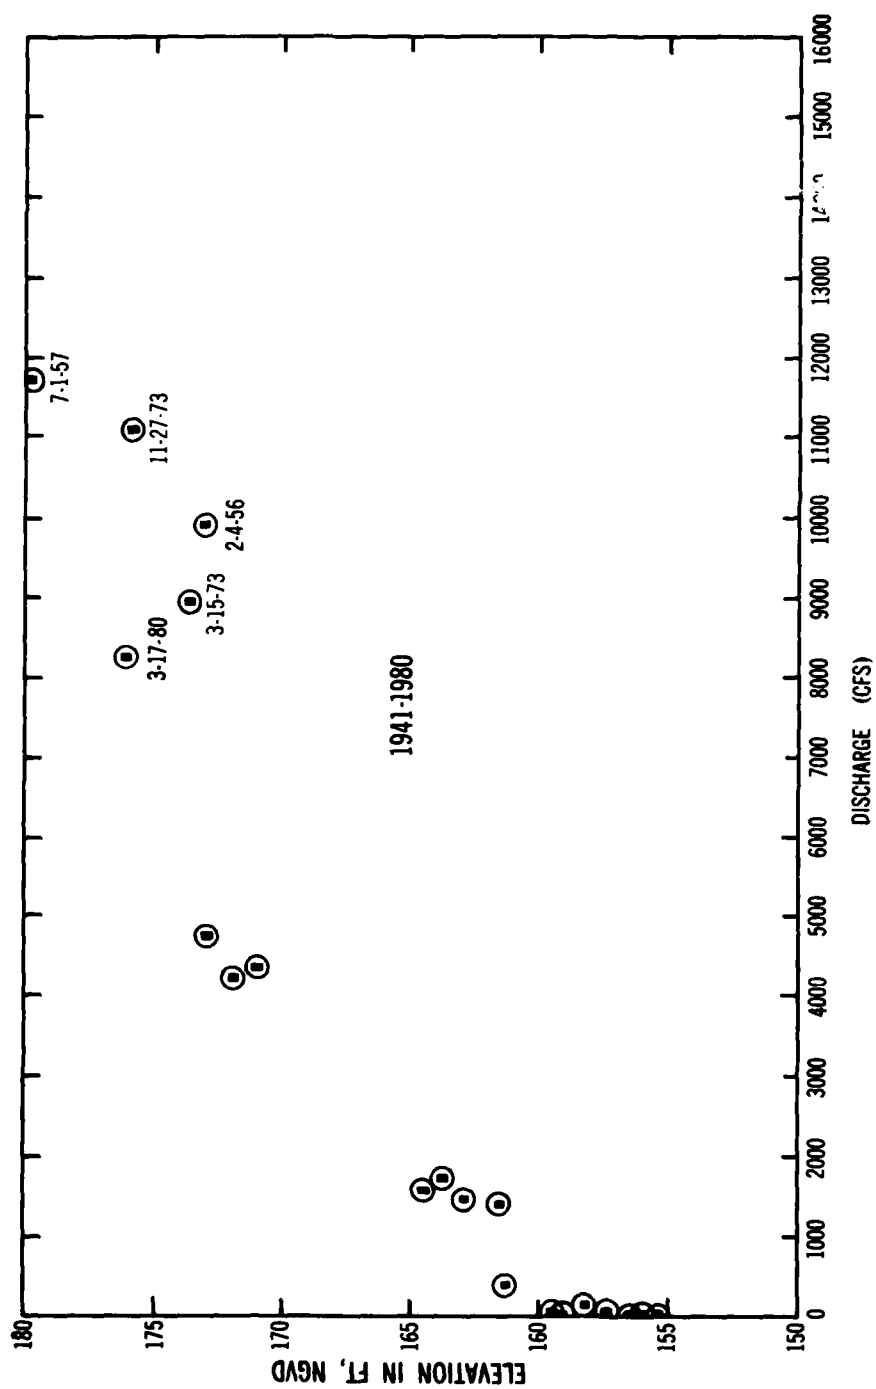
Figure 60. Rating curve, South Fork, Highway 35

(1) South Fork Tillatoba Creek. The period of record dates from January 1941 to the present; however, very little flow information was gathered on South Fork Tillatoba in recent years. The highest recorded stage on South Fork was 181.33 feet, NGVD, at the Highway 32 bridge at Charleston, on 29 May 1974. Other stages are shown on the rating curve in Figure 60, and are listed in the following table.

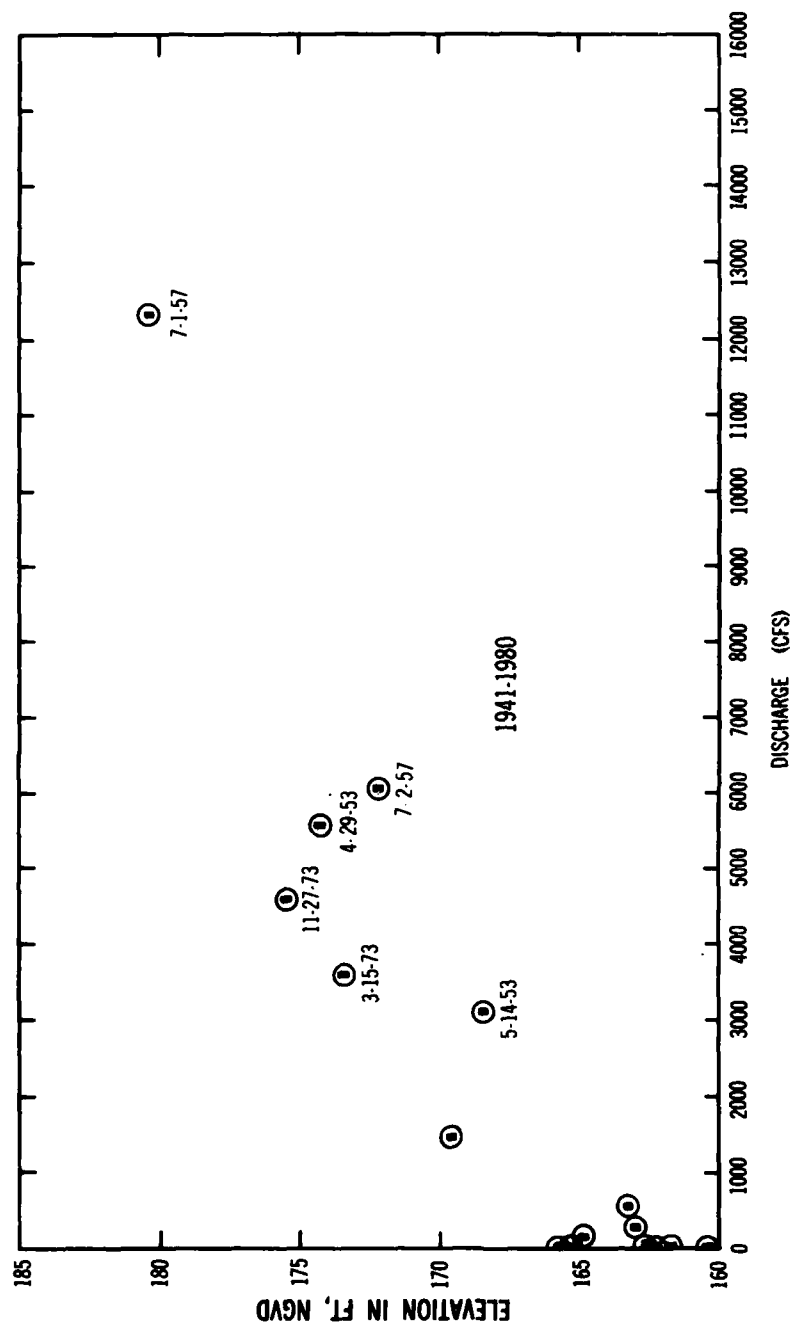
Figure 61. Rating curve, North Fork, Highway 35

(3) North Fork Tillatoba Creek. Flow data, similar to that taken for South Fork, is also available for North Fork Tillatoba at the highway bridge west of Charleston. The maximum recorded stage was 180.37 feet, NGVD, on 1 July 1957. A rating curve prepared from the available data is presented in Figure 61 along with the actual data listed in the following table.

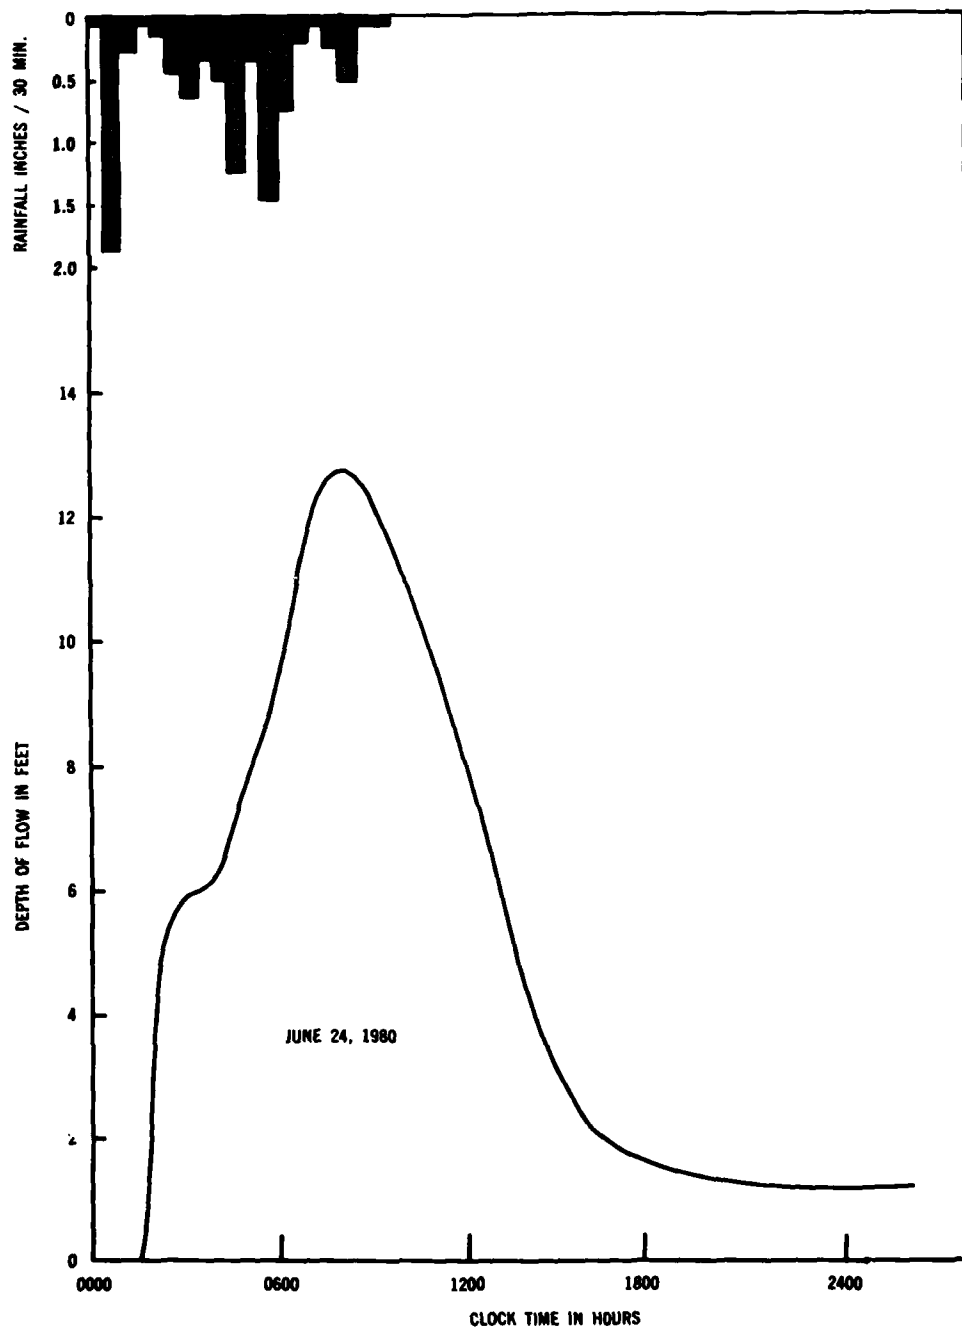
Figure 62. Hydrograph at Item 3A, North Fork, Tillatoba Creek

When grade control structure 3-A was completed on North Fork, an automatic stage recorder was installed, along with rainfall recorder. The stage hydrograph, plotted in Figure 62, indicates the "flashy" nature of the small drainage basin hill stream. In the 30 days prior to the 24 June 1980 storm, almost no rainfall fell; therefore, the volume of runoff was somewhat decreased by infiltration. The stage and corresponding accumulated rainfall are given in the following table.

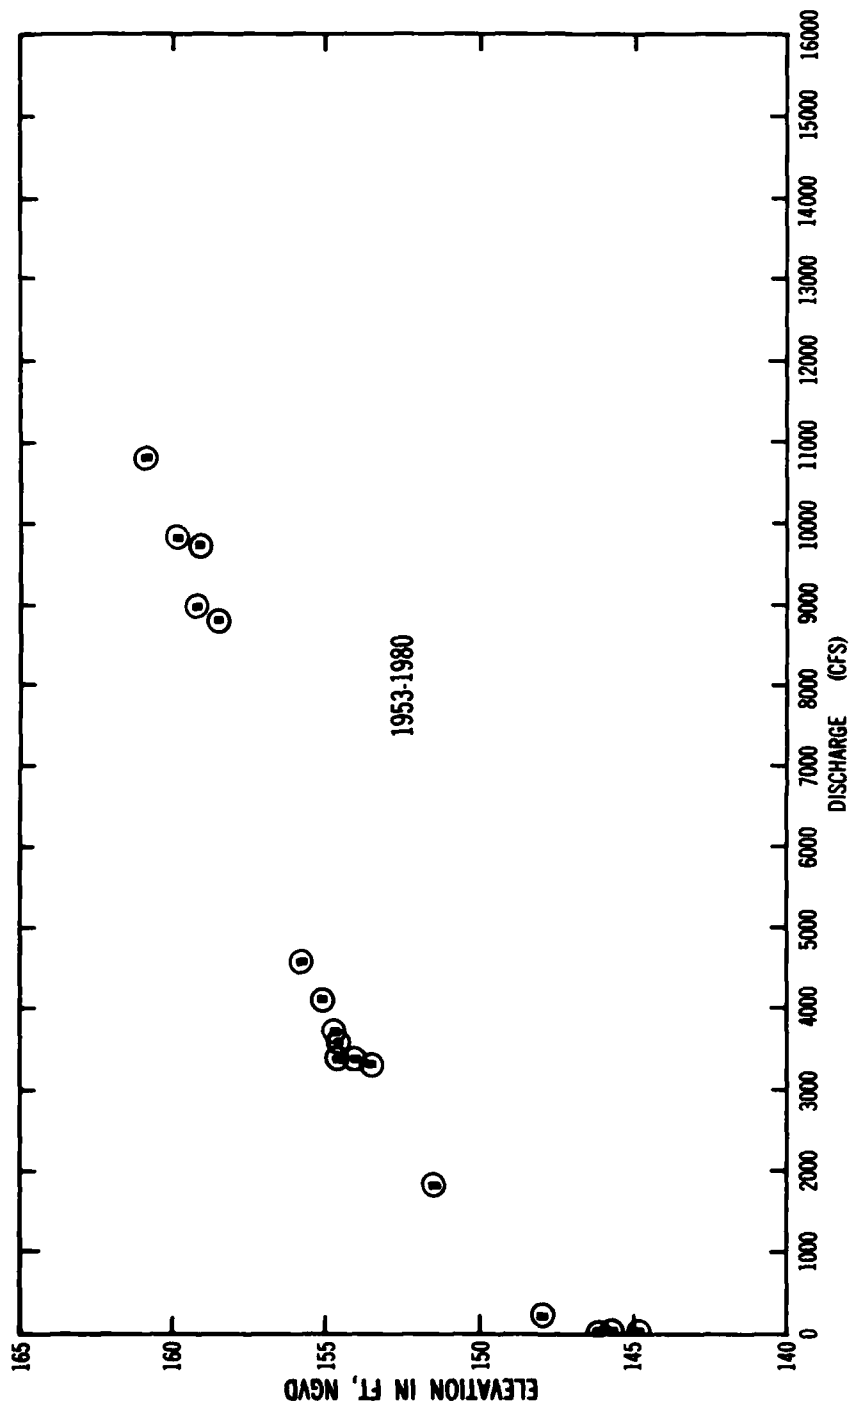
Figure 63. Rating curve, Tillatoba Creek

(4) A rating curve for Tillatoba Creek proper, about 3-1/2 miles downstream from the confluence of North and South Fork, is given in Figure 63. No change is evident in the rating curves from the sparse data over a 27-year period.

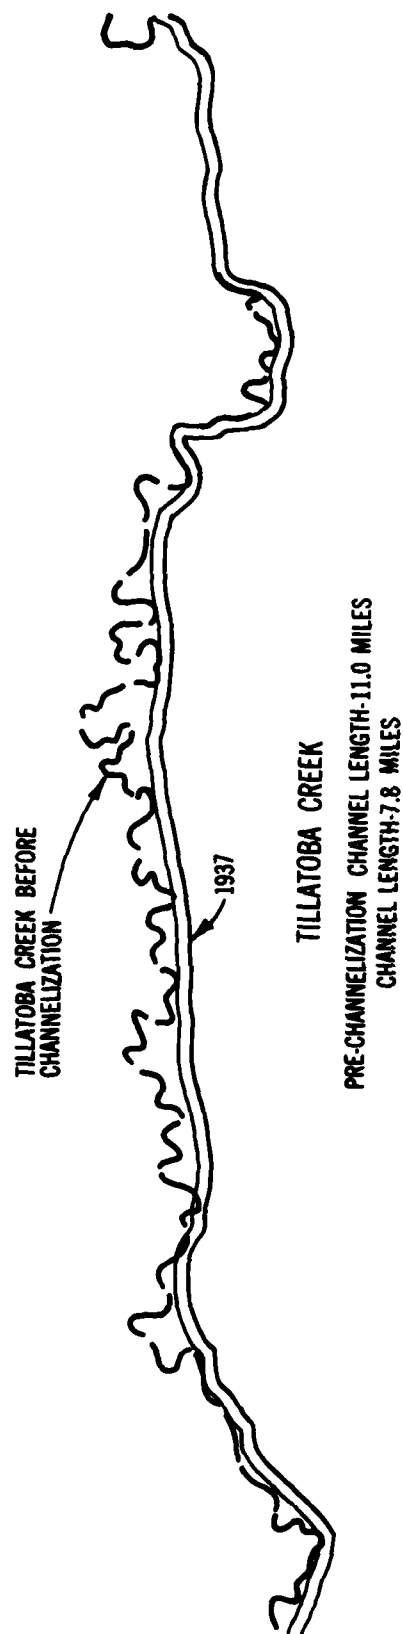
Figure 64. Plan view comparison, Tillatoba Creek after channelization

7. Channel Changes. Ninety-nine percent of the Tillatoba Creek Basin is in the Yazoo Basin hills. The 7.8 miles of channel in the delta were channelized during the 1920's and 1930's (Figure 64). Middle Fork, tributary to South Fork, is the only channel in the basin to be partially channelized.

Figure 64 shows the channelization and straightening of the Tillatoba Creek stream channel in the delta flatlands prior to 1937 and the considerable reduction in channel length (Whitten & Patrick, 1980). Photos indicate the channel width doubled from 1937 to 1979. The increase in width may have occurred at a uniform rate, unlike the well-defined erosion locations of degradation in upland channels.

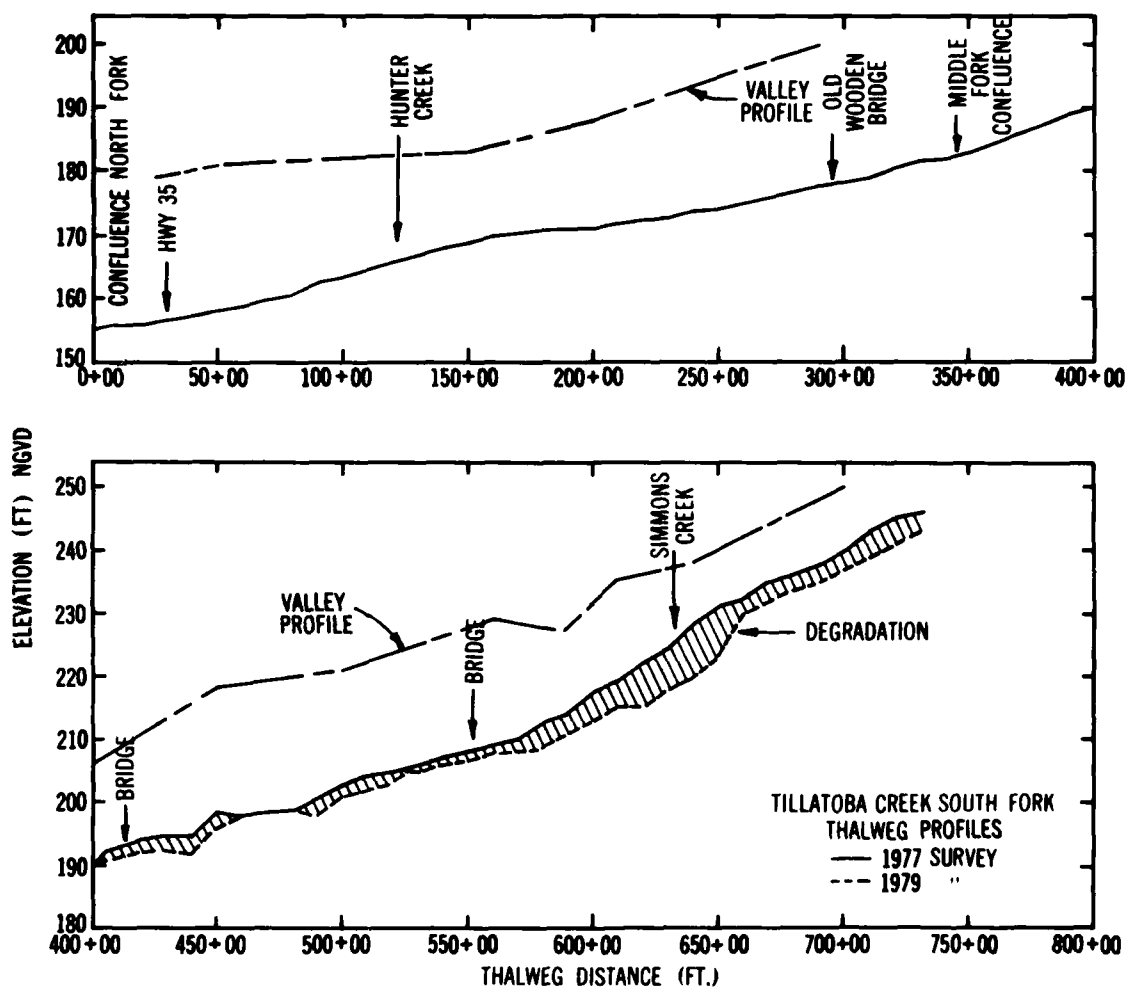
Figure 65. Thalweg profile, South Fork, Tillatoba Creek

Degradation and bank erosion are presently occurring at an excessive and rapid rate. Figure 65 is presented to show the extent and

rate of degradation on the South Fork channel from 1977 to 1979. The active segment begins 8 miles above its confluence with North Fork and continues upstream with a magnitude of variation, generally increasing upstream from 2 to 8 feet. Similarly, Figure 66 shows thalweg profiles on North Fork from its mouth upstream 8 miles. Active degradation begins 1 mile above the confluence with South Fork and continues upstream with a more uniform variation of 1 to 2 feet.

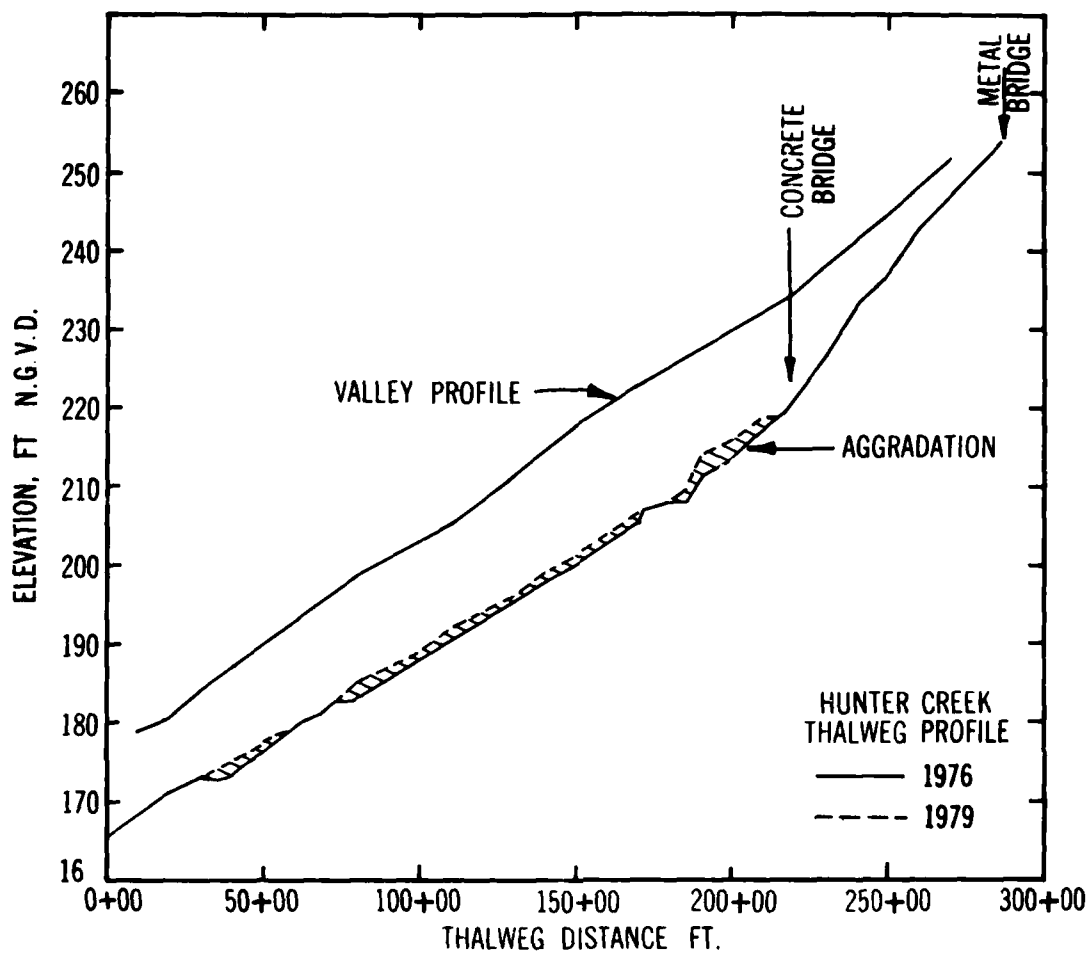
Figure 67. Thalweg profile, Hunter Creek

Hunter Creek is a South Fork tributary 2-1/2 miles upstream from the mouth. Photos of Hunter Creek taken in 1937 show the channel lined with vegetative growth with no observable erosion. Photos indicate that by 1941 degradation was advancing upstream near the mouth. The channel more than doubled its width from 1941 to 1954, and the channel continued to widen and deepen from 1954 to the early 1970's. Figure 67 shows the aggradation which occurred for the lower 4-1/2 miles of this channel from 1976 to 1979. This figure shows a generally uniform 2 feet of aggradation for this segment of the channel. 1979 photo coverage shows the

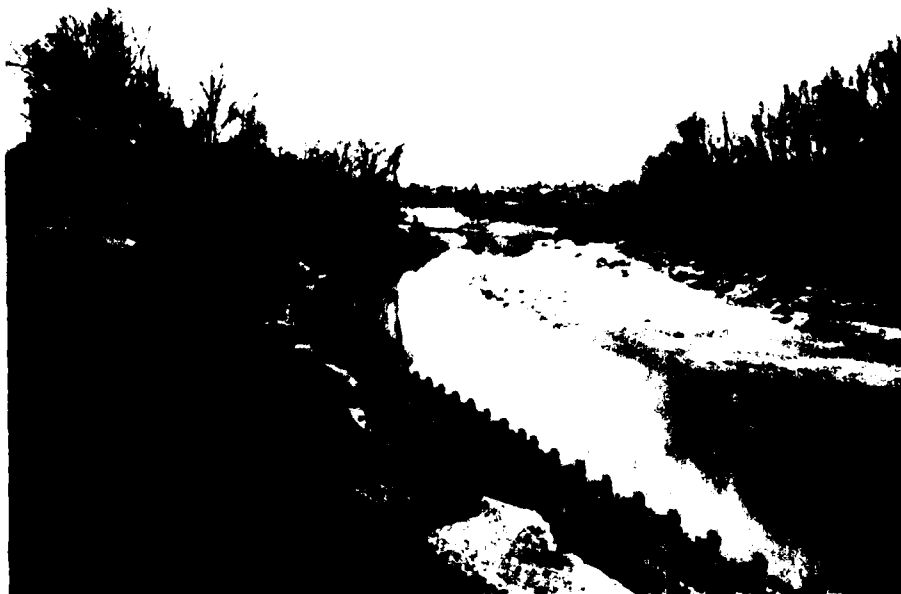
Emntv Tire Crib Retards After  
Several High Events  
Looking Downstream  
Jan 1978

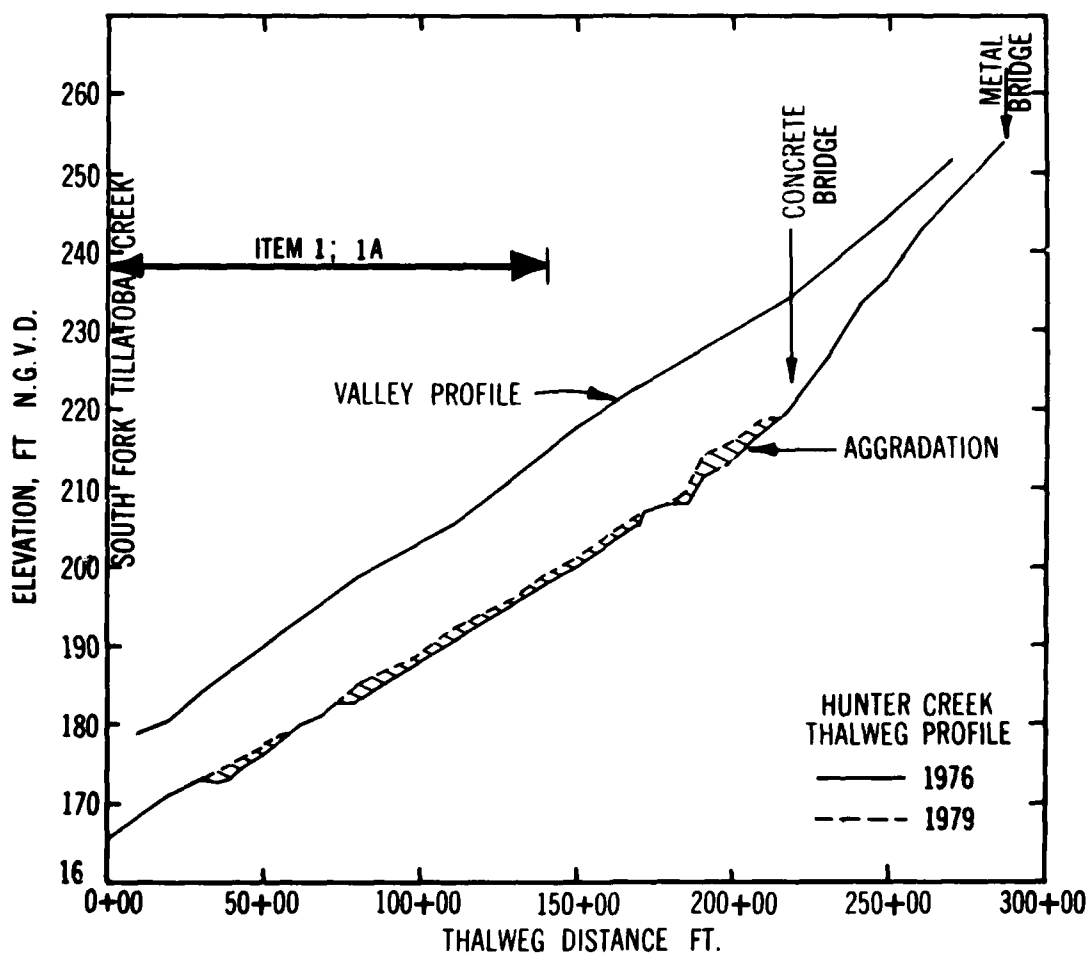
Figure 101. Hunter Creek Valley and Thalweg profile

equilibrium state; (2) the streambed experienced several feet of aggradation since 1976 (Figure 101) which increased the sediment accumulations within the channel; and (3) the stabilization structures were of greater strength in relation to the size of the drainage area than those used on the larger streams such as Batupan Bogue and South Fork Tillatoba Creek.

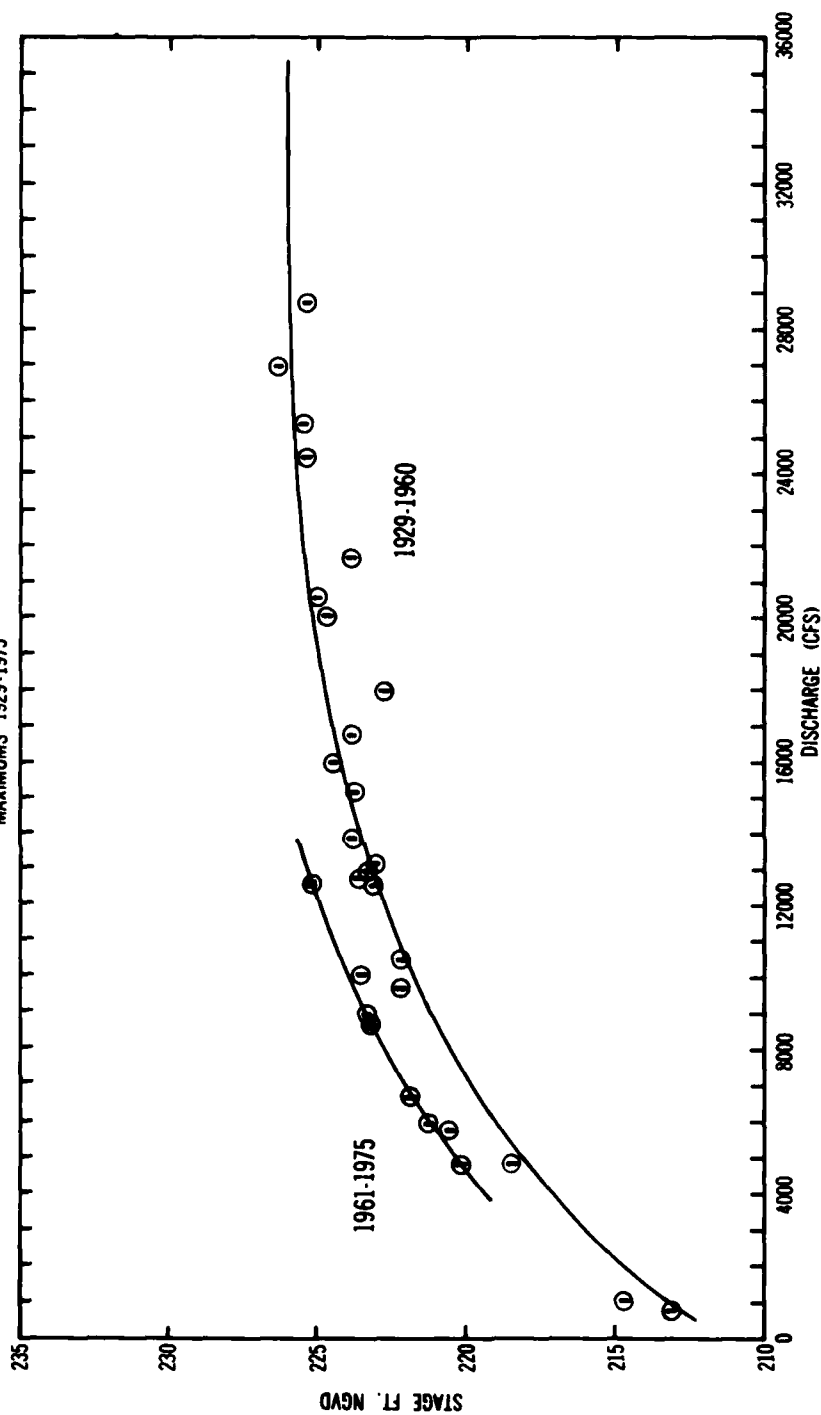
Figure 105. Rating curve, Peters Creek, Highway 51 Bridge

The available data are presented in the form of a rating curve at Figure 105. USGS records indicate that the location of the gage has remained constant and it may be assumed that the upward shift in the rating curve is due to aggradation. Two low-water measurements made in 1979 (not on rating curve) indicate a reverse in this trend, probably as a result of channel enlargement due to headcut migration. Based on the discharge information in Figure 105, a rough approximation of discharge for Johnson and Goodwin Creeks may be found by use of the ratio of drainage areas. Johnson Basin is about 19.1 square miles, or 29 percent of the area above the Courtland gage, and Goodwin Creek Basin is about 8.5 square miles, or 13 percent, of the total basin.

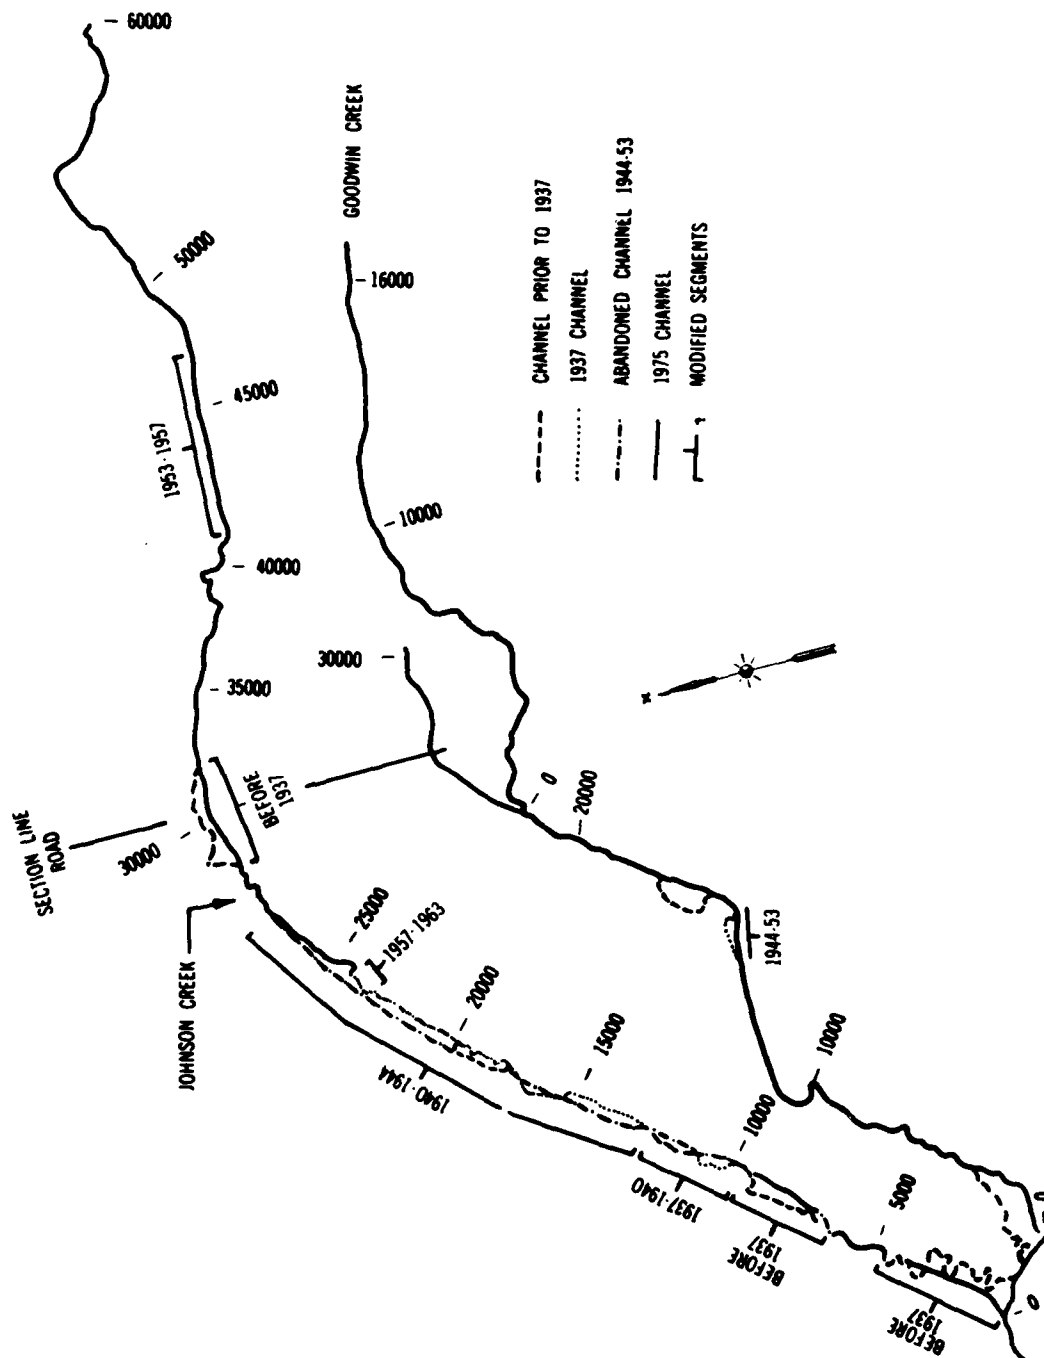
Figure 106. Johnson Creek channel changes

7. Channel Changes. Goodwin and Johnson Creeks experienced both channelization and base level lowerings. Channelization that began prior to 1940 and continued into the mid 1950's (Figure 106). The base levels of these creeks were lowered following the Yocona River channelization, the Enid Lake construction, the flow changes imposed by construction of Panola-Quitman Floodway, and the numerous other alterations to channels in the Yazoo Basin. Prior to 1968, channel erosion was gradual but after 1968 bank erosion was more pronounced. The channel width doubled with very irregular vertical banks and numerous well-developed point bars.

b. Johnson Creek channelization occurred prior to 1957. Aerial photos show the alterations of the prechannelized stream. The channelized reaches of Johnson Creek are shown on Figure 106.

The channelized segments of Johnson Creek prior to 1937 were between reaches 77+00 and 96+41 and below reach 41+47. Additionally, a lateral ditch was constructed between reach 290+00 and 326+87 but was not the main channel until between 1940 and 1944. By 1944 most of Johnson Creek had been channelized except for approximately 1/2 mile of channel beginning at sta 27200. The channelized section did not capture the main flow prior to 1944, and segments of both the natural and modified channel were alternately carrying the flow. The 1953 photographs show segments of the channelized section inactive and the natural channel carrying the flow. These inactive segments are indicated in Figure 106 from section 120+00 to 136+17 and 191+22 to 259+75. Additionally, incomplete channel straightening occurred above 410+00.

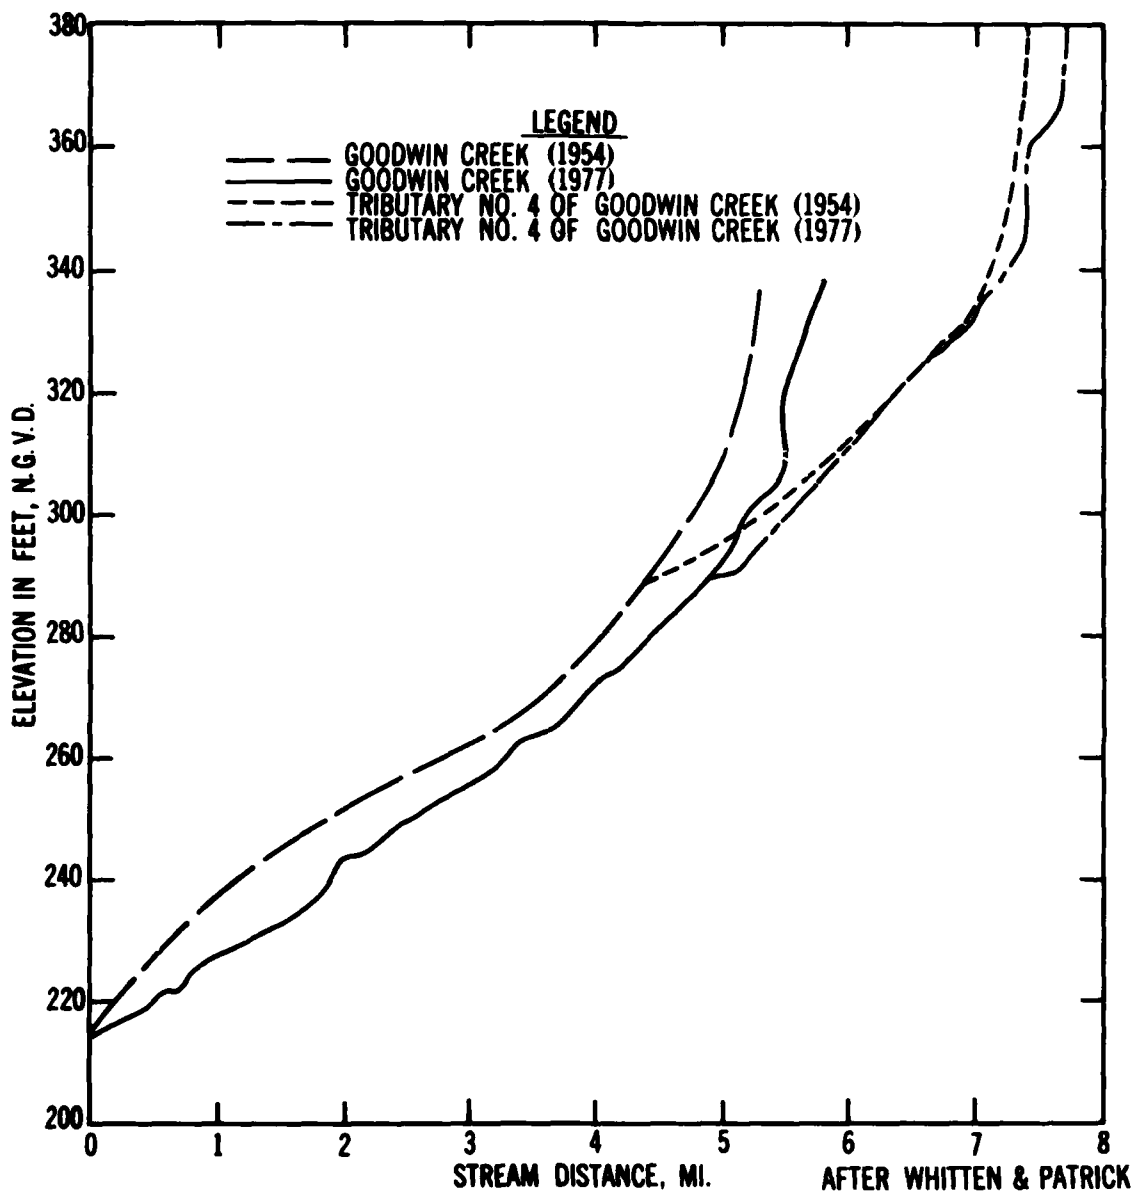
Figure 107. Longitudinal profile, Goodwin Creek

Comparison of the 1954 and 1977 longitudinal profiles of Goodwin Creek shows that the headcut in the lower reaches in 1954 had advanced upstream by 1977 (Figure 107 after Whitten and Patrick, 1980). Channel irregularities, in many instances, reflect erosion-resistant points (clay ledges) that have temporarily halted degradation.
